# Spot what's wrong with this house and you don't need a building survey!

**ASHDOWN LYONS**

CHARTERED SURVEYORS

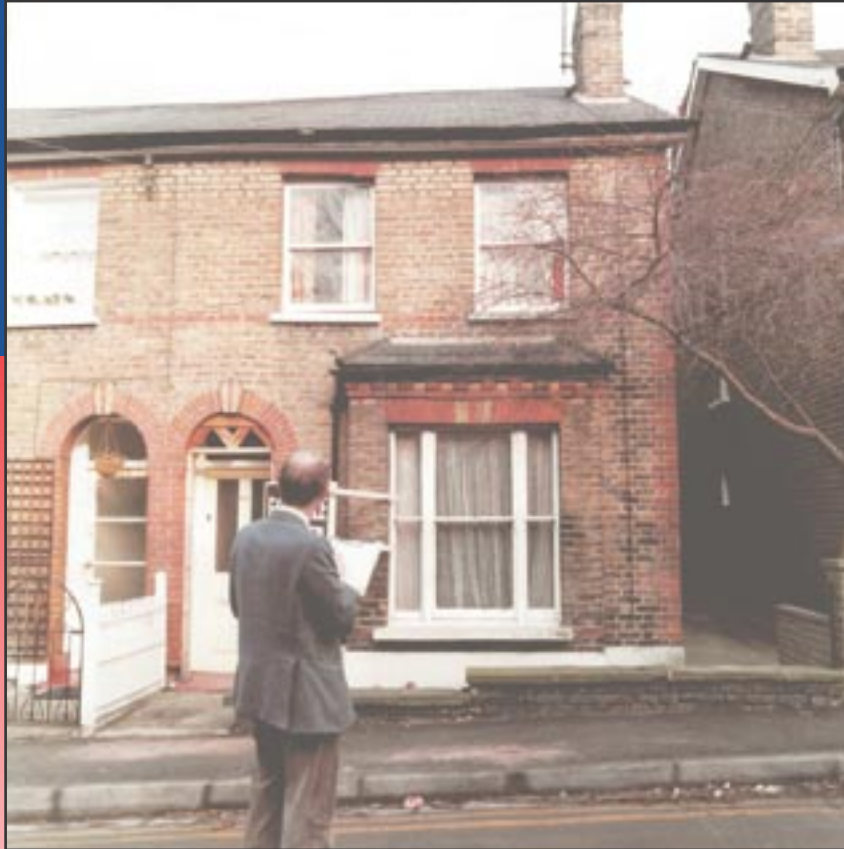
## Main Defect

### Distortion to structure.

See first floor window sills which have dropped, failing brickwork above first floor left hand window and cracking above door opening.

1. No restraint to right hand flank wall as first floor joists span from front to rear.
2. Timber beam spanning bay opening has rotted.

1. Open up structure and replace beam above bay opening.
2. Restrain right flank wall.
3. Rebuild brickwork above first floor left window.
4. Re-point cracks above front door.
5. Renew flashing to front bay roof in lead.

1. Overhaul main roof – missing slates.
2. Renew chimney stack flashings in lead.
3. Staining to main eaves gutter which leaks. Replace this gutter and provide down pipe.
4. Re-point front boundary wall.
5. Cut back encroaching tree.

Did you spot that the door opening is now being propped up by timber posts and an upper frame?

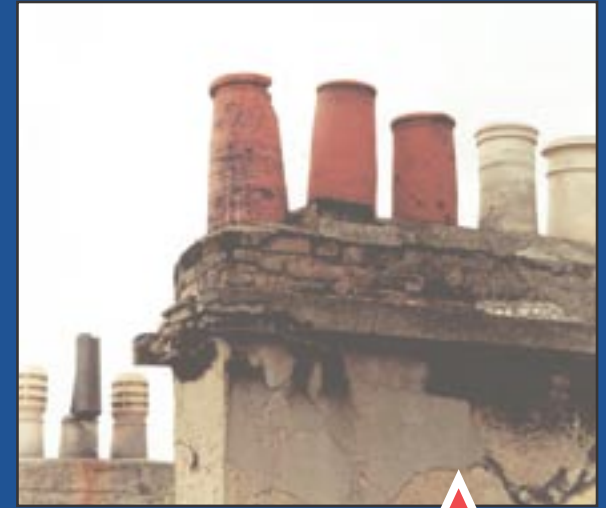
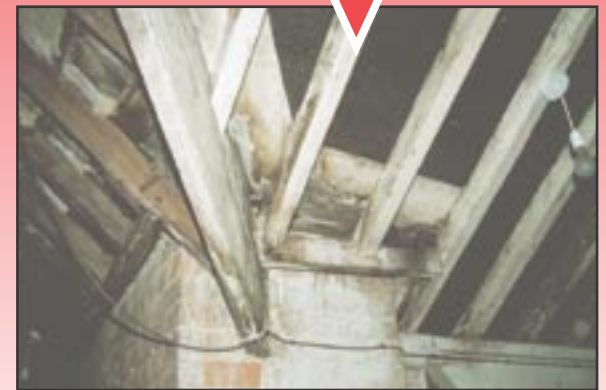
Not visible from ground level, **this** caused **this**

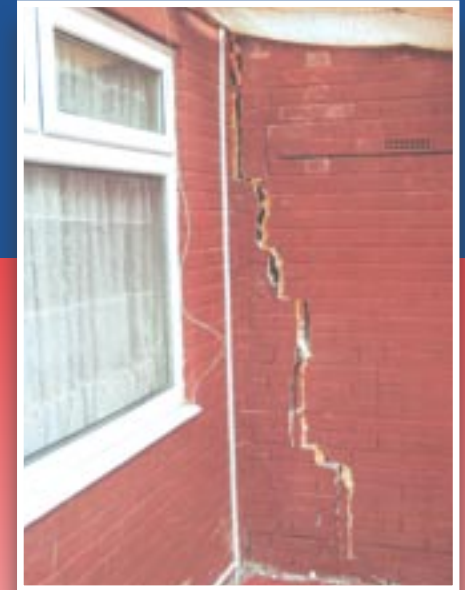
### Substandard extension

Client informed and didn't buy.  
Cracks appeared two months later.  
Would you have known this was  
going to happen? Our clients did.
